Arbed-Esch 3-Strand Rod Mill Report w/ Ending 26 January 1963

5 February 1963

ARBED-ESCH 3 STRAND ROD MILL REPORT

W/ENDING 26 JANUARY 1963

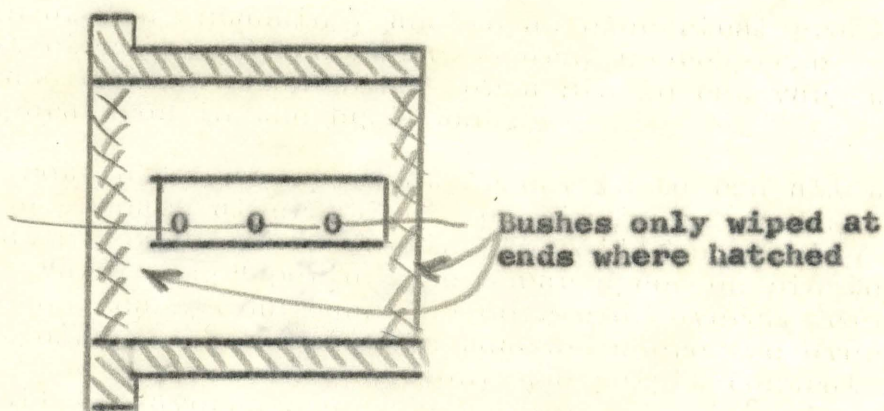
An examination of a set of finishing mill Morgoils which were taken out of the mill last week showed three of the white metal bushes wiped, two slightly, one severely. They were all top chocks, one on Stand 18 and two on Stand 22. Inspection showed that in each case the wiping was confined to each end of the bushes and that the area in the centre, in the region of the oil pocket, was undamaged. See Sketch:-

The symptoms were that the bearings had been run for a short period with a reduced amount of oil, maybe sufficient to prevent the middle zone of the bush from picking up, but not enough to spread the oil to the outside edges.

Enquiries into the procedure of starting the mill up at 6 o'clock in the morning, raised doubts as to whether enough time was being allowed for the oil to circulate through the chocks before running the mill up to maximum speed. A new procedure will be adopted and special care taken while the very cold weather lasts, to see that the oil is reaching the top chocks at the correct temperature and that the mill is turned over at base speed for 5 minutes before running up.

A modification to the oil supply pipes from the two reduced pressure stations will also be made in order to feed oil to the slower speed stands first as done at Felten. I am also hoping to get electric heating tapes and lagging fitted to the pipework. It may be significant that the affected bearings namely Stands 18 and 22, were each on the end of a supply header.
